## Jicable 2003 Paper B.3.4

### ***“A Multidiscipline 35 kV Cable Failure Investigation”***

HARRY ORTON, GABOR FURST, JOE BATHO, International Consulting Engineers,  
Vancouver, BC, Canada

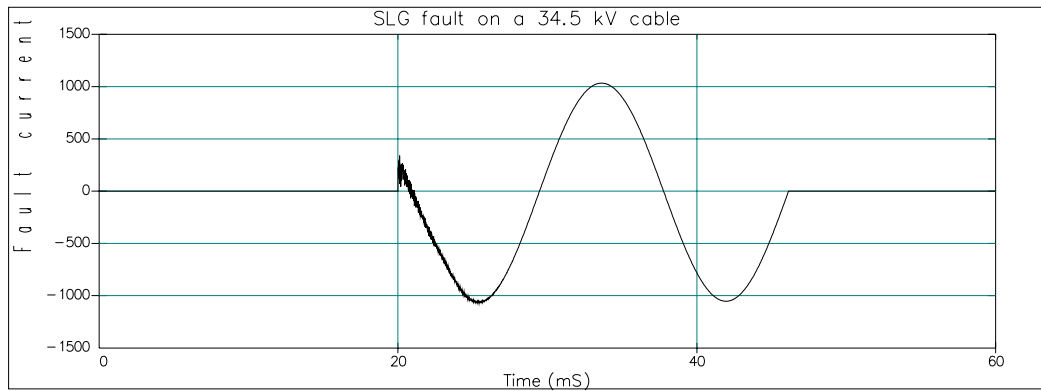
Figure 1 shows the fault current for a single line to ground fault. The current shown is about 1100 A r.m.s. close to the 1200 A recorded during the actual incidence. Figure 2 shows the voltages on phases B and C during the SLG fault on phase A. The voltage rise on the sound phases is 47 kVp, approximately the normal phase-to-phase voltage, 34.5 kV r.m.s.

**Figure 1**  
Closing onto a SLG fault. Fault current in phase A r.m.s.

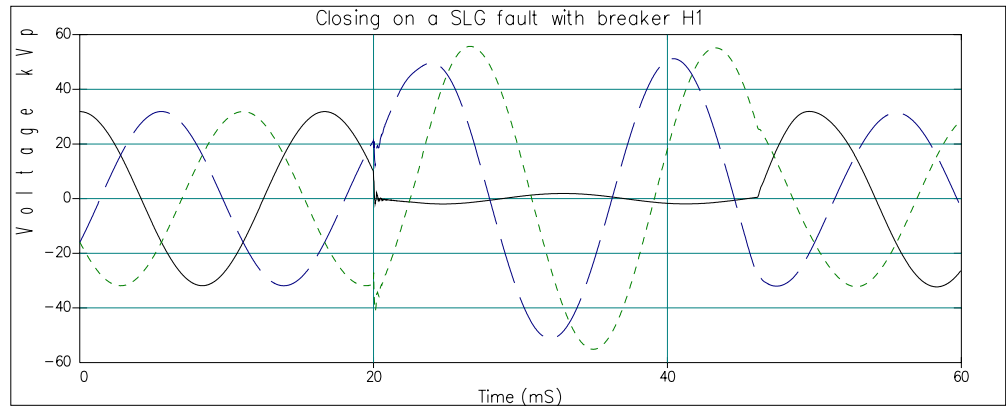
**Figure 2**  
Closing onto a SLG fault. Voltage rise on sound phases kVp ph-g.

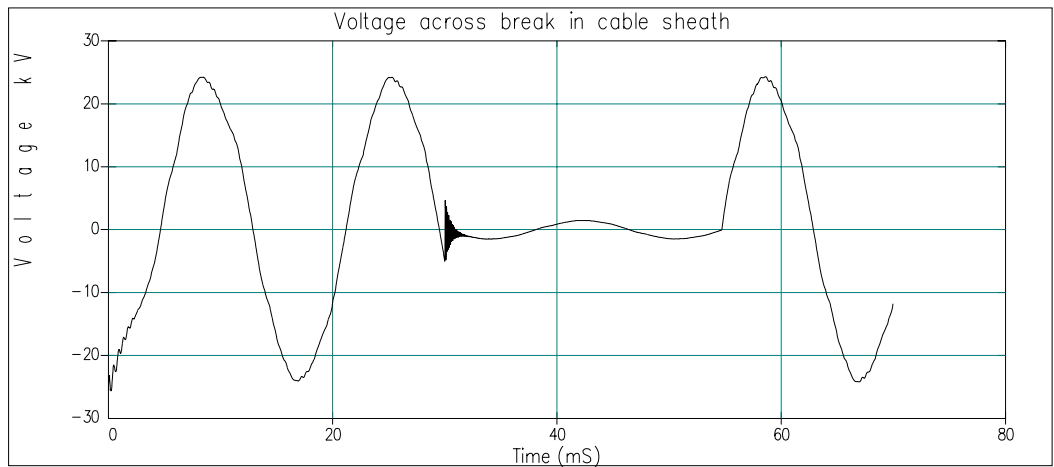
Figure 3 shows the voltage stress across a discontinuity in the cable sheath (copper tape). This stress reaches the value of the phase-to-ground voltage across the gap in the tape. Depending on the length of the gap this would lead to arcing or tracking across the insulation and result eventually in insulation failure and a fault to ground.

**Figure 3**  
Voltage across a gap in the shielding copper tape  
Sparkover followed by recovery

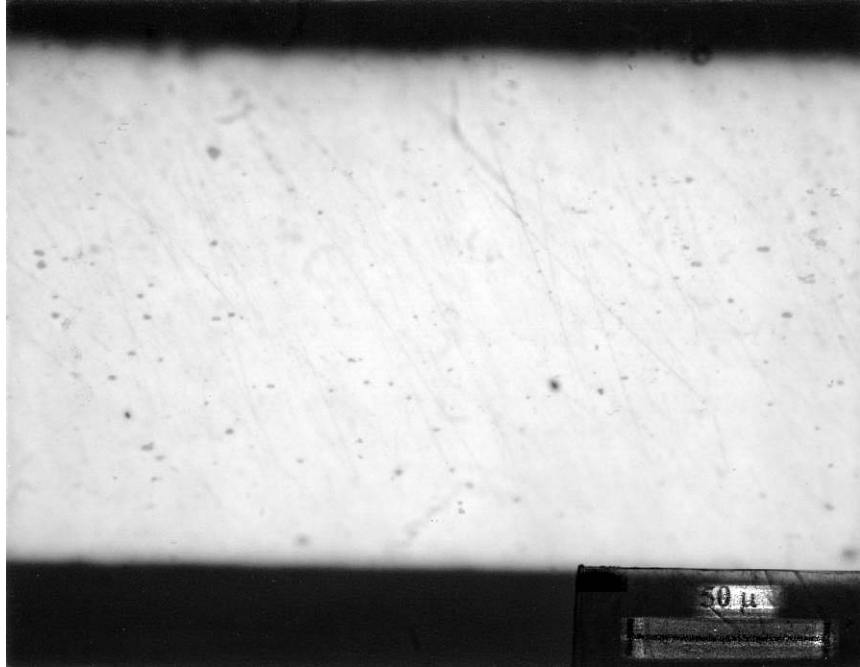
The first part of the metallurgical investigation assessed the copper tapes taken from a new cable (unused) from the manufacturer's plant (see Figure 4). The second part assessed the integrity of the copper tapes taken from a failed cable (see Figure 5).

The micrographs in each figure show a marked difference in the material properties of the copper tapes. Figure 5 shows the presence of tramp elements and oxide inclusions, while Figure 4 is free of these contaminants.

**Figure 4:** Microstructure of the edge of the copper tape taken from a new and unused cable. (Mag. 500X)

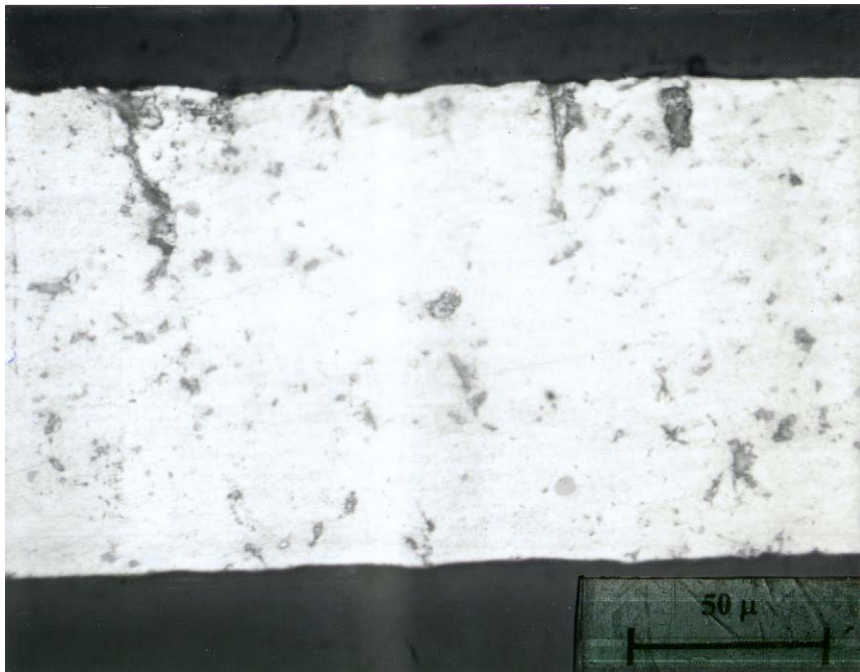
- Tramp elements and oxide inclusions appeared at localized areas along the edge of the copper tape of the failed cable. These defects reduced the tape's tensile strength and elongation.
- Bending and pulling the cable through a sharp radius can easily wrinkle the copper tape of the failed cable. Certain parts of the cable can be exposed to an excess of 3000 lbs of load when the cable catches around the sharp bend. When the edge of the copper tape that contains the defect is caught in this way, the copper tape will fracture due to mechanical overload.

Hence, it is concluded that the fracture of the copper tape of the cable took place due to a combination of the defect on its edge and an abnormal bending operation. It appears that these two factors individually would not fracture the copper tape.

**Figure 5:** Microstructure of the edge of copper tape sample showing tramp elements and oxide inclusions. (Mag. 500X)
